drawing title PHOTOS IDENTIFYING PROPOSED WORKS		ASHLEY COURTNEY RIBA AABC ARCHITECT 36 Roseford Road, Cambridge CB4 2HD tel: 01223 750610 email: ac@ashleycourtney.co.uk				
client COTON PCC	job title URGENT REPAIRS	scale NTS	date NOV 2020	job no. 20-27	dwg no. 09	rev

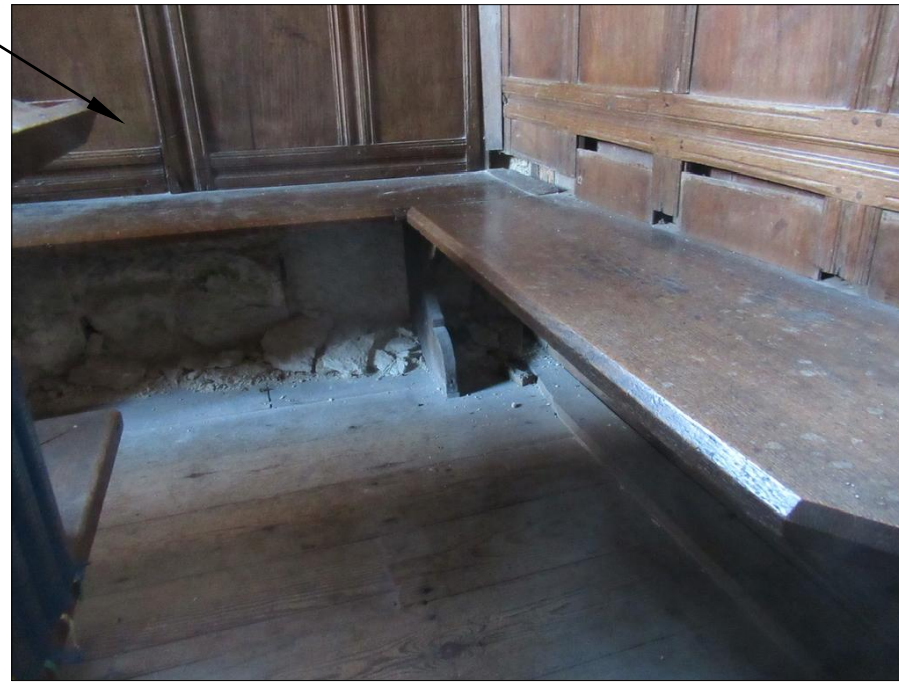
CHOIR STALLS - DETAIL SHOWING COLLAPSE AND SPOILED STONework

Items 11.1 - 11.10 specialist joiner to carefully dismantle choir stalls, investigate reasons for its collapse, carry out repairs subject to Architect's inspection and instruction, and reinstate choir stalls on completion
