| drawing title PHOTOS EXISTING | | ASHLEY COURTNEY RIBA AABC ARCHITECT 36 Roseford Road, Cambridge CB4 2HD tel: 01223 750610 email: ac@ashleycourtney.co.uk | | | | |
| client COTON PCC | job title URGENT REPAIRS | scale NTS | date NOV 2020 | job no. 20-27 | dwg no. 04 | rev |

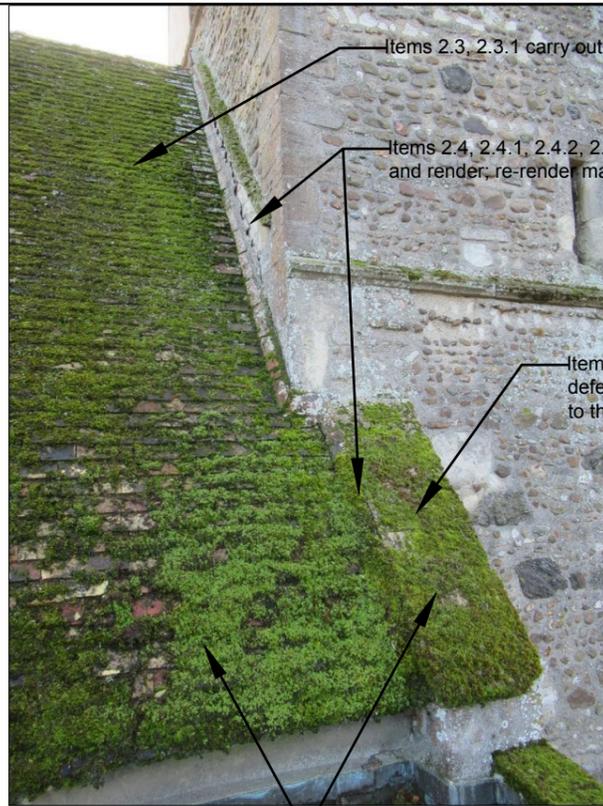
NAVE, NORTH SLOPE - WEST ABUTMENT

Items 2.4, 2.4.1, 2.4.2, 2.4.3, 2.4.4, 2.4.5 remove and dispose of defective tile listing and render; re-render margin of walling and supply and fit new tile listing

Item 2.4.5 rake out and repoint defective joints to weatherings to this buttress/parapet

Items 2.3, 2.3.1 carry out tiling maintenance to both slopes

Items 2.1, 2.2 provide protection for all works to nave roof and remove moss to both north and south nave slopes

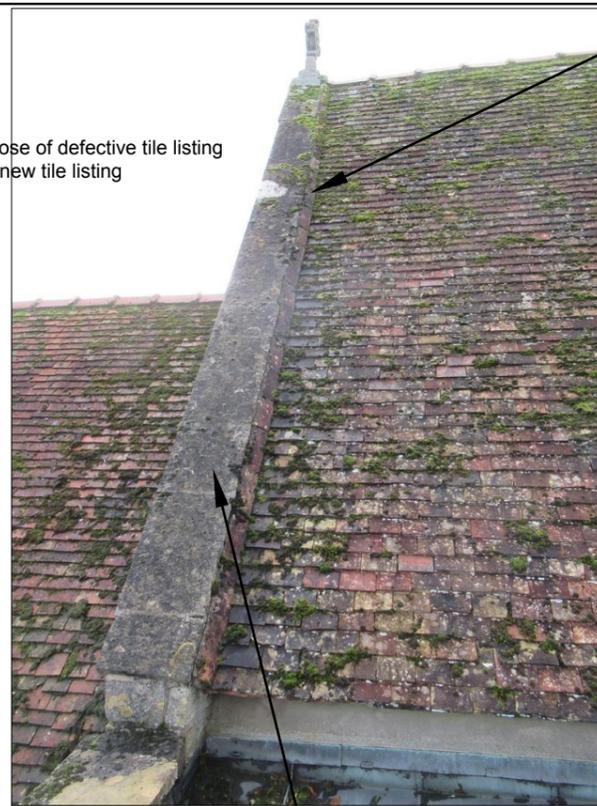
NAVE, NORTH SLOPE - EAST ABUTMENT

Items 2.5, 2.5.1, 2.5.2, 2.5.3, 2.5.4 remove defective tile listing and replace

Item 4.4 remove moss to parapet
Item 4.3.2 rake and repoint 4Nos. defective coping joints

Item 2.6, 2.6.1 allow to repoint 2Nos. coping joints and to take off and rebed 1No. coping stone anywhere on this slope

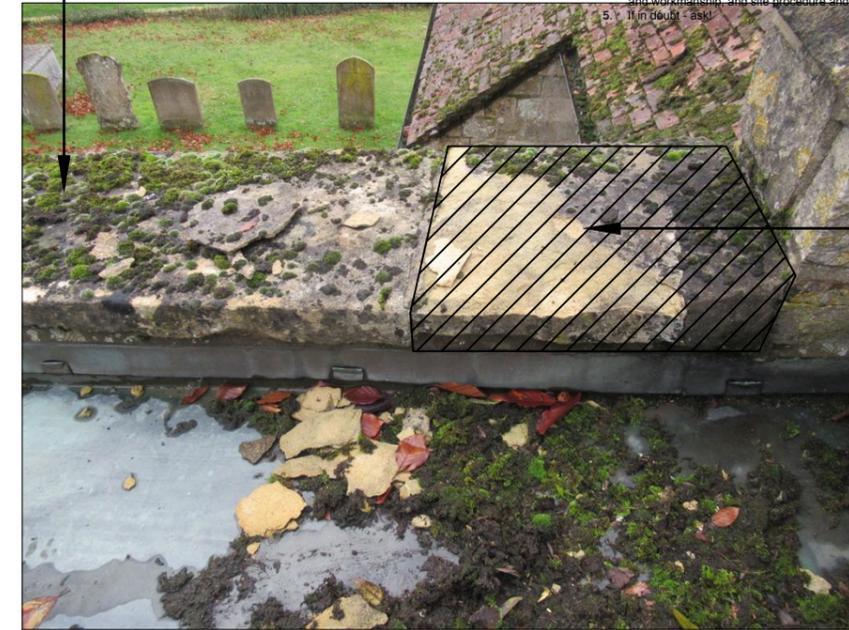
NORTH AISLE - EAST PARAPET

Item 4.3.1 replace defective coping stone

Items 4.1, 4.1.1 carry out maintenance to north aisle roof

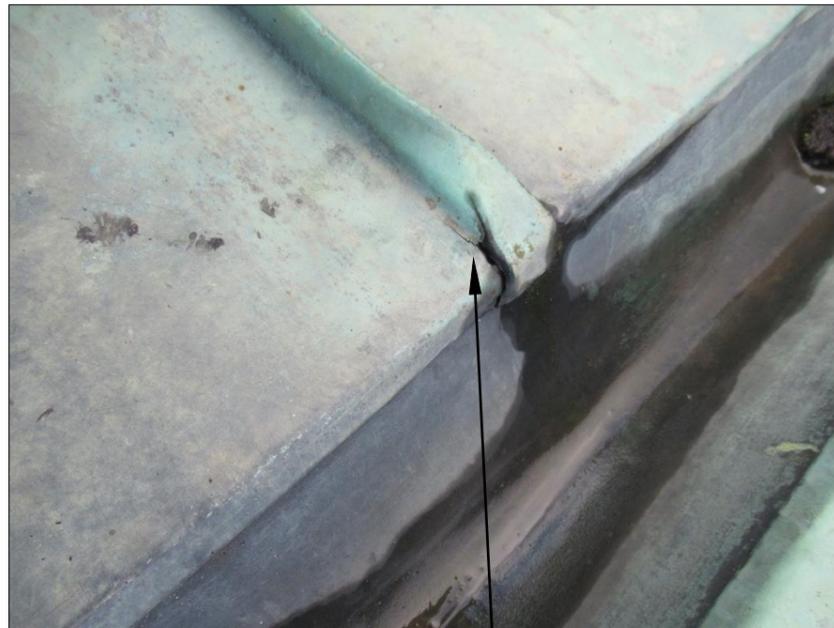
NORTH AISLE ROOF - TYPICAL SPLIT

Items 4.4, 4.4.1 carry out repairs to copper roof covering

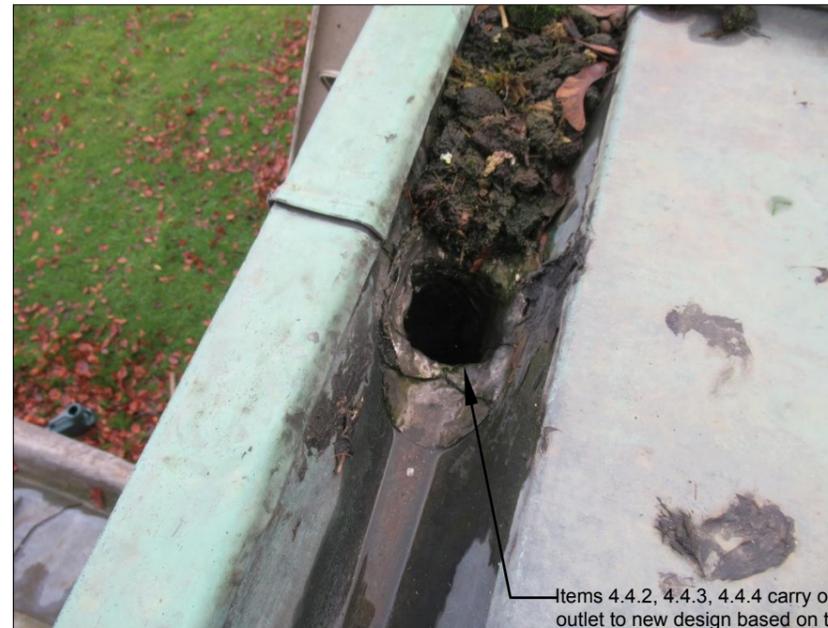
NORTH AISLE ROOF - ONE OF TWO OUTLETS

Items 4.4.2, 4.4.3, 4.4.4 carry out alteration to gutter outlet to new design based on that to south aisle; see also dwg No. 20-27/07

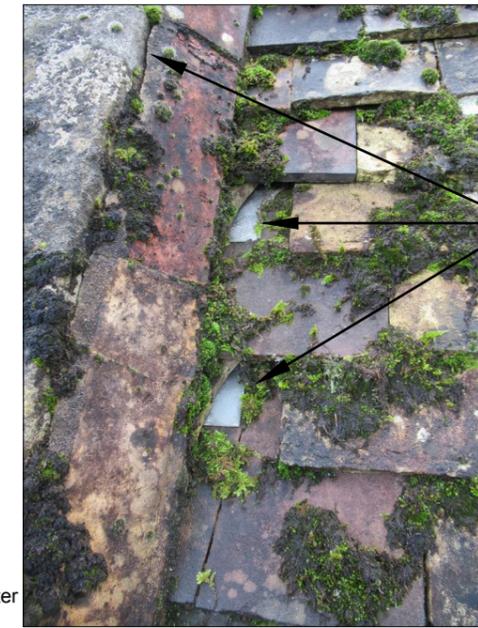
NAVE, NORTH SLOPE EAST ABUTMENT DETAIL

example of defects to east abutment
